Technical Service Bulletin

42 Rattle noise from rear suspension

42 17 37 2038689/2 April 18, 2017. Supersedes Technical Service Bulletin Group 42 number 14-22 dated December 10, 2014 for reasons listed below.

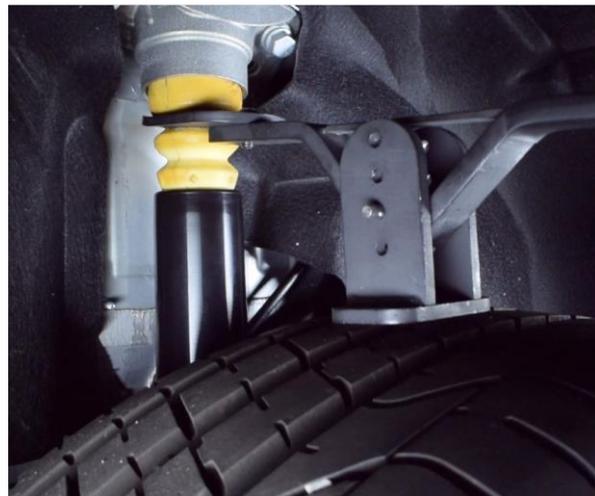
Figure 2. The SET900 tool being used to install a rear bump stop.

1. Clean the top of the rear bump stops and coat with tire mounting paste.
2. Use the SET900 special tool to fully press the rear bump stops in to the upper shock mounts (Figure 2).

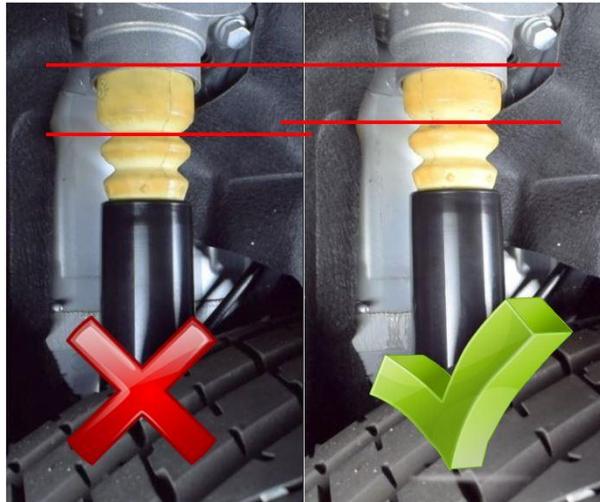
The purpose of the tool is to properly seat the rear bump stops in the rear shock mounts (Figure 3), which will prevent them from dropping out of the rear upper shock mounts and causing noise.

Figure 3. Comparison between rear bump stop installation without and with the SET900 tool.

Always ensure that the dust boot does not get caught on the top of the shock once the vehicle is lowered.
